**Traffic Advisory Leaflet 4/98**  
**April 1998**

# Toucan Crossing development

This leaflet provides a summary of the results of trials carried out into the use of prototype nearside signals at Toucan Crossings (see TRL Report 331).

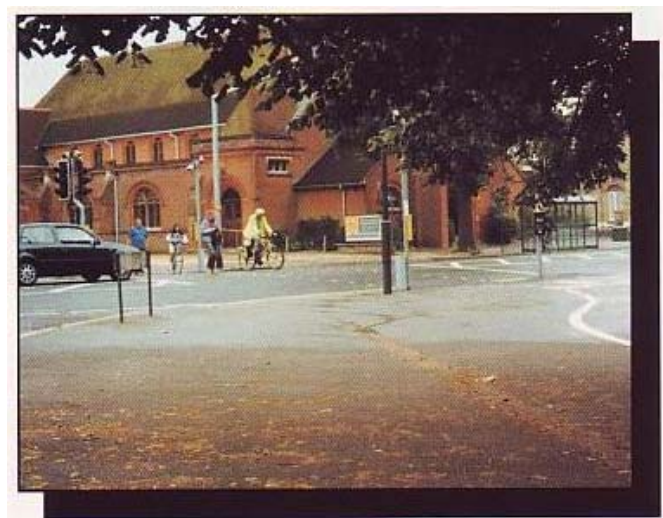
### ***Toucan nearside signal aspects***

Aspects were designed with a curved face incorporating green/red cycle and pedestrian symbols. The curved face was chosen, as it was felt that this might improve the visibility to approaching pedestrians and cyclists. However, from some angles only the cycle symbol or the pedestrian symbol could be viewed, but not both. The signals together with the push button unit were to be located on either side of each crossing approach. The push button was constructed as a separate unit to be located immediately below the signal unit. The push-button itself was much larger than that used for far-side Toucan Crossings, and illuminated when pressed. No advantage was found in mounting the push button unit with a gap between it and the signal unit. Future regulations will permit the push button and nearside aspects to be assembled as one complete, or two separate, units. The push button unit was mounted so that the centre of the push button was 1.06m above the adjacent footway, to ensure reasonable access to wheel-chair users and children.

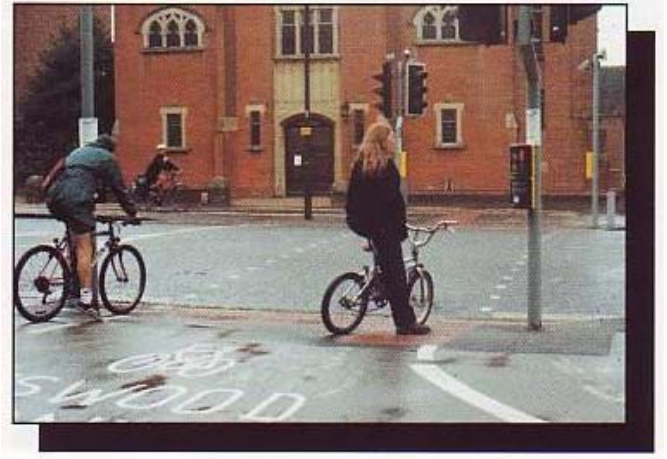
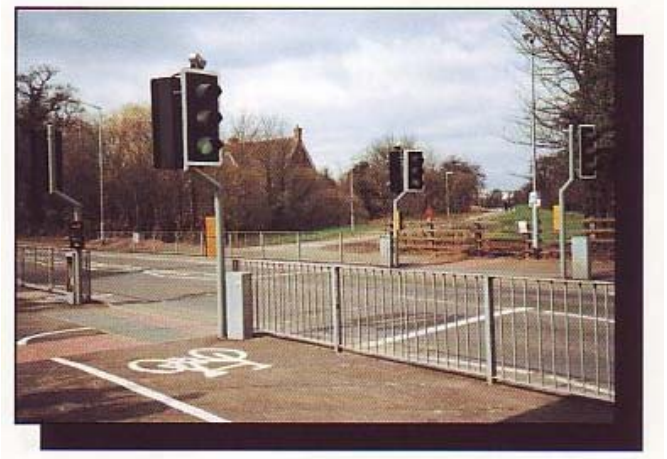
### ***Induction loops***

Early forms of cycle-only signal crossings had incorporated inductance loops, rather than push buttons. However, the majority of Toucan Crossings have been installed with push buttons only. There may be some advantage in having both push buttons and loops and it was felt that this should be investigated as part of the trial. The loops needed to be compatible with the kerb-side detector, and allow sufficient time for a cyclist detected by the loops to reach the kerbside detection area. It was also essential that the loops were uni-directional, so that cyclists leaving the crossing did not register a demand.

Inductance loops may offer some value to cyclists, depending on the arrangement of the cycle approach. However, no particular disadvantages have emerged at those sites where inductance loops were not used.
